Durham E-Theses

Slope instability along the north-west coast in Malta

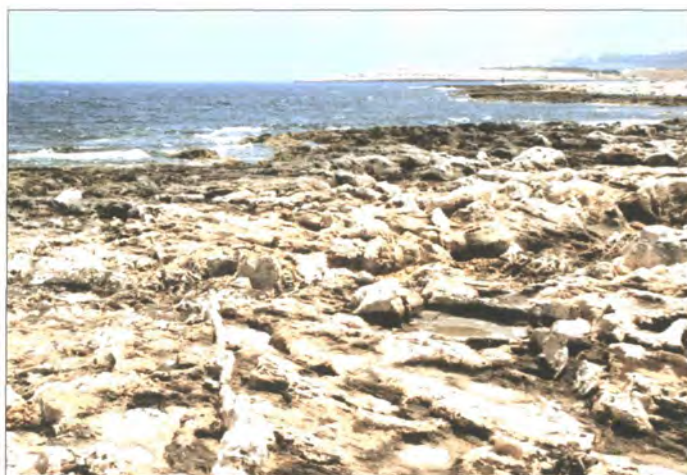
Plate 3.4: Low rocky shore cut in Lower Coralline Limestone on the north-east coast. Pools and lapiés which produce a very irregular surface are the result of corrosion.

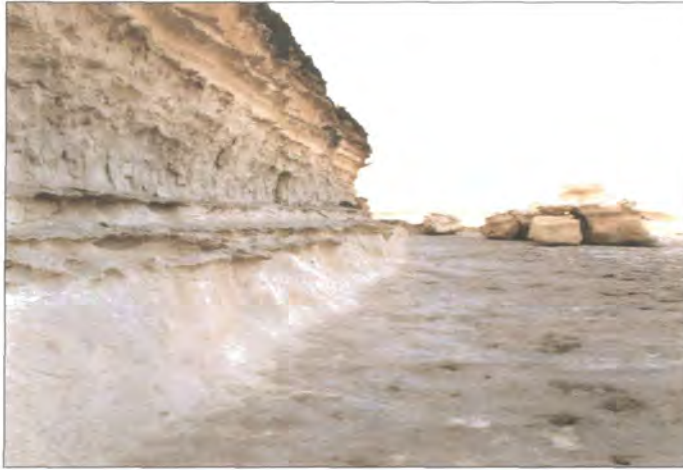
Plate 3.5: Low cliff and shore platform formed in *Globigerina* Limestone, characteristic of the southern coast. *Globigerina* Limestone being a softer material than Coralline Limestone displays a smoother surface. This is mainly the result of the mechanical action of waves, especially hydraulic pressure.

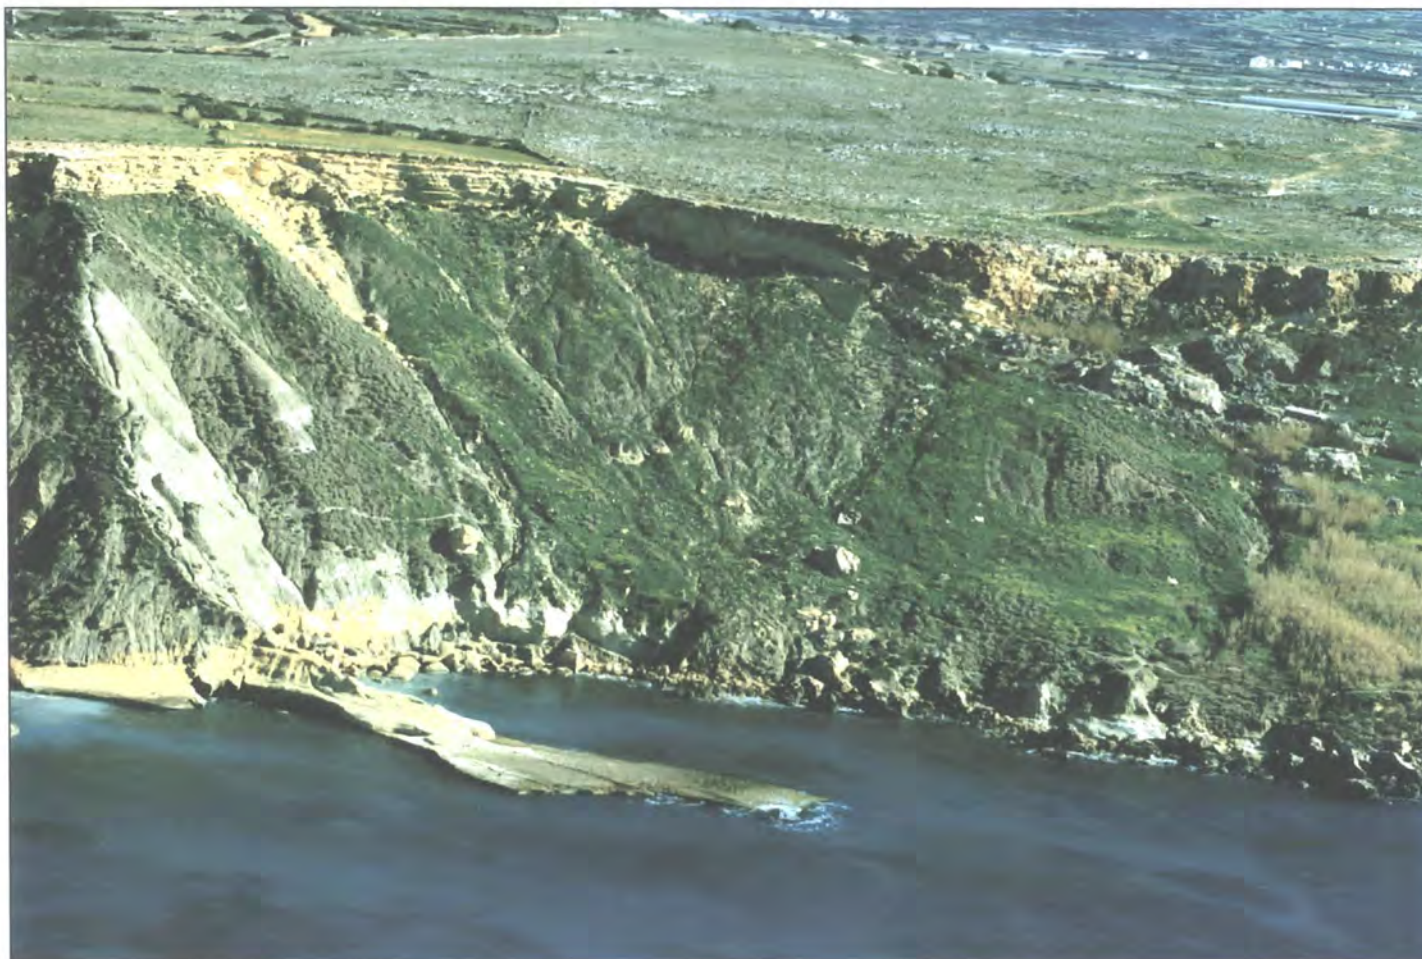
Plate 3.23: Clay slopes examined at Gnejna Bay, close to the reeds. Slopes in this section are vegetated since the gradient is not so steep. The Upper Coralline Limestone plateau and scarp face are visible in the background, whereas the Globigerina Limestone cliff and shore platform are seen in the foreground. The reeds at the lower right side mark the southern limit of the area under study.

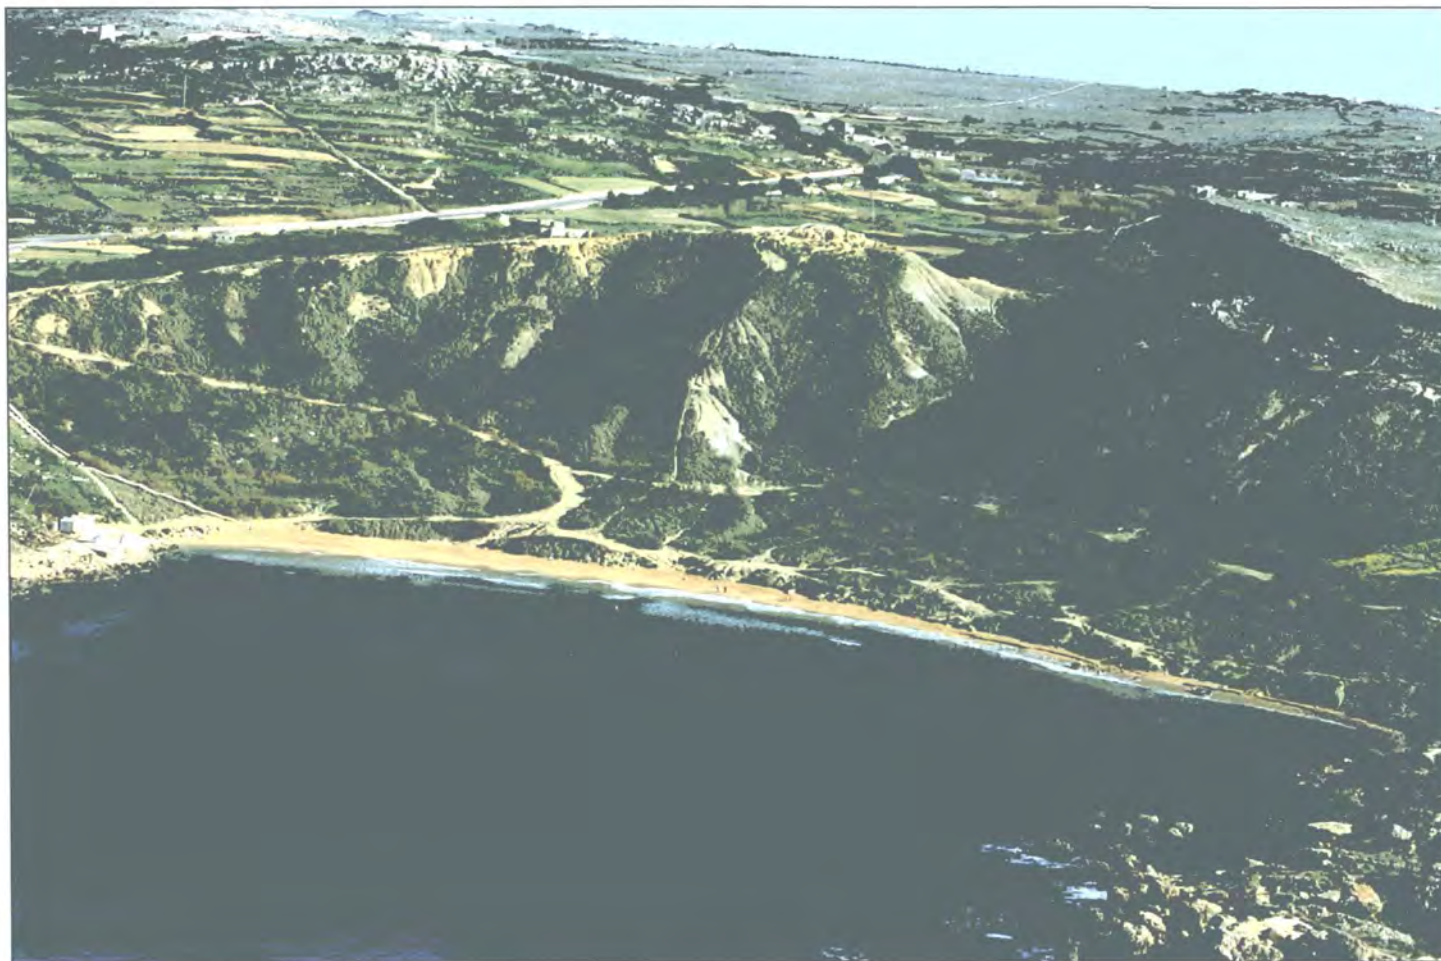
Plate 3.24: An aerial view of Ghajn Tuffieha Bay. The clay slopes extend from the back of the sandy beach to the base of the Upper Coralline Limestone plateau. The sandy beach stretches along the whole length of the Bay. Ghajn Tuffieha Bay has been designated as an area of ecological importance by the Planning Authority in 1995 and is a protected site by law. The Bay is at present managed by the GAIA Foundation, a Non-Governmental Organisation which was responsible for a recent afforestation project.
